Manhole Inspection Summary

Manhole # S25E__019MH

Insp Date: **8/7/07 8:56 AM**

Location Address: **1145 SARATOGA ST**

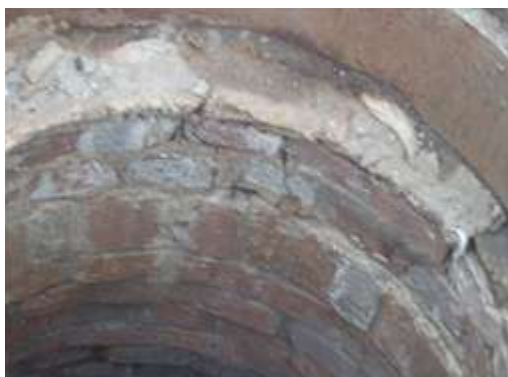
Defect 4

Condition: ☐ Sound ☐ Cracked ☐ Root Intrusion ☐ Loose Brick ☒ **Deteriorated**

DETERIORATION OF CORBEL

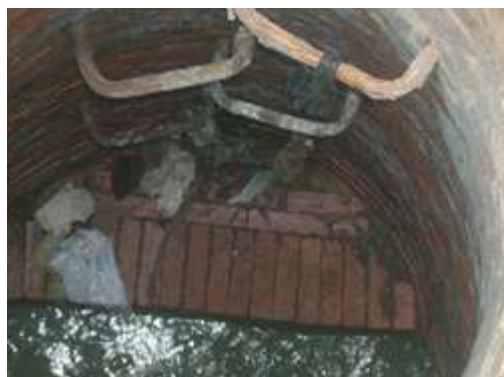
Defect 3

Count: **6** Missing: **2** ☒ **Corroded**

☒ **Evidence Of Surcharge** Depth: **6** (ft.) ☐ Active Surcharge Present

CORRODED STEPS AND SURCHARGE
EVIDENCE ON STEPS

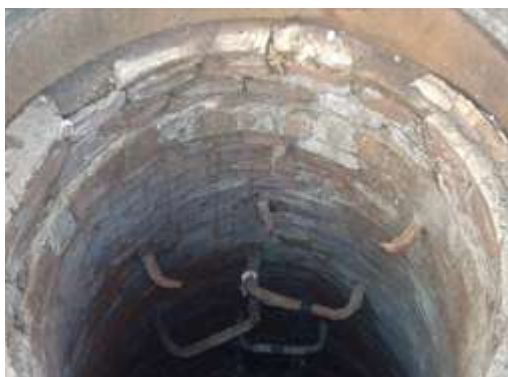
Defect 2

MISSING STEPS

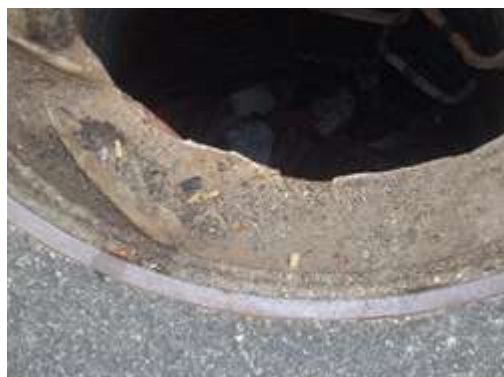
Defect 1

Offset: **6** (in.)

FRAME OFFSET

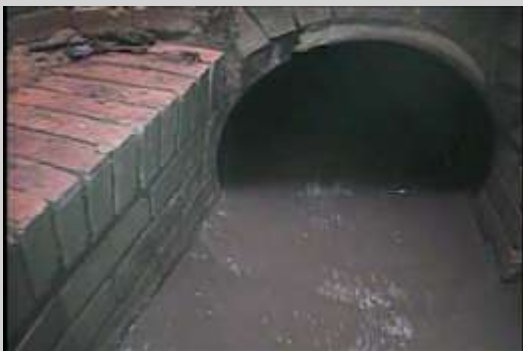
7 O'Clock Inflow

21 in. Circular Gravity Sewer
Pipe In @ 7 O'Clock

Pipe Height: **21.6** (in.) Rod and Bar (Angled)
Pipe Material: **Clay** ☐ Pipe Lined
Invert Depth: **12.69** (ft.) Flow Characteristics: **Slow**
Deposits: ☒ None ☐ Mud ☐ Sludge ☐ Debris ☐ Grease
Silt Depth: (in.) Deposits Extent:
Infiltration: **None** Pipe Seal Cond: **Broken**
